Test Report Date: 21 Dec 2018 No. CANEC1825886011 Page 1 of 4

The following sample(s) was/were submitted and identified on behalf of the clients as: SOD-323 Semiconductor

Model No.: SOD-323 Client Ref. Info. : SOD-123

<u>Halogen</u>

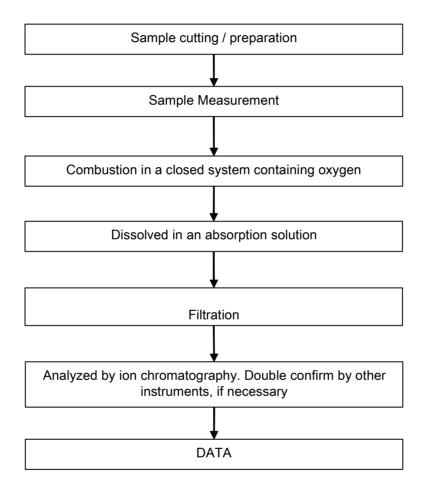
Halogen Testing Flow Chart

Test Method: With reference to EN 14582:2016, analysis was performed by IC.

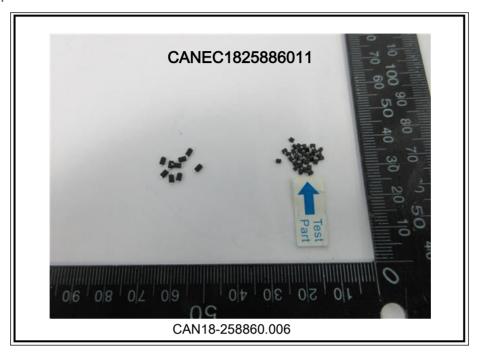
Sample photo:

> SN₁ CAN18-258860.006 Black body w/ brown printing & silvery metal pin
